GLEN CANYON DAM SPILLWAY TUNNEL REPAIRS, 1983 - 1984

Bill McCormick, Gary Boring, Keo Civil, LLC

Contract No. 3-CC-40-01100

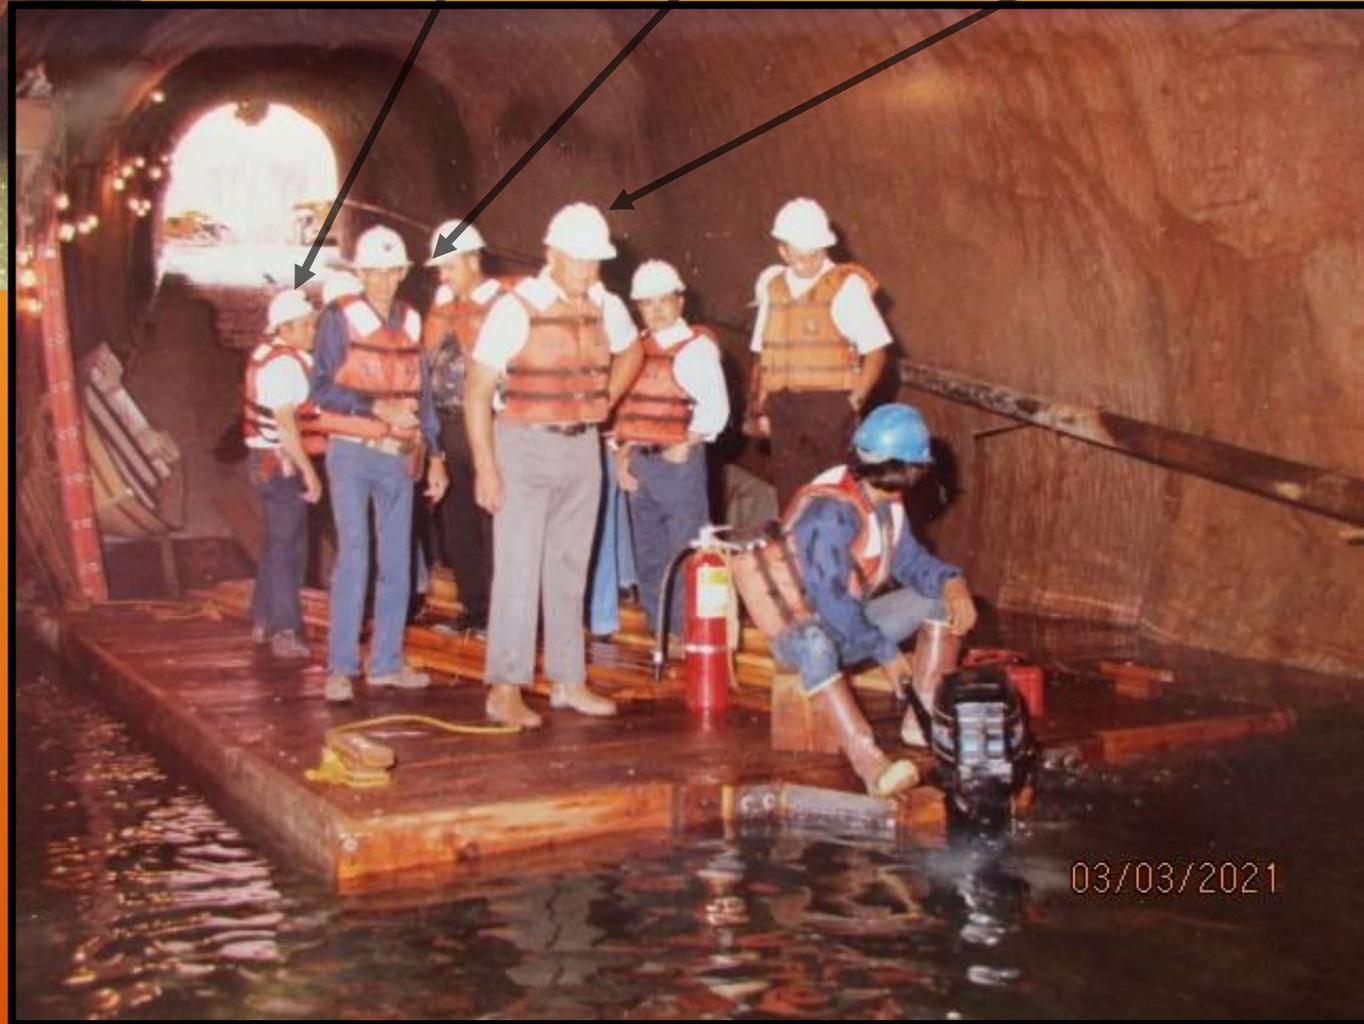
Intact Concrete Lining

Exposed Rebar

Navajo Sandstone

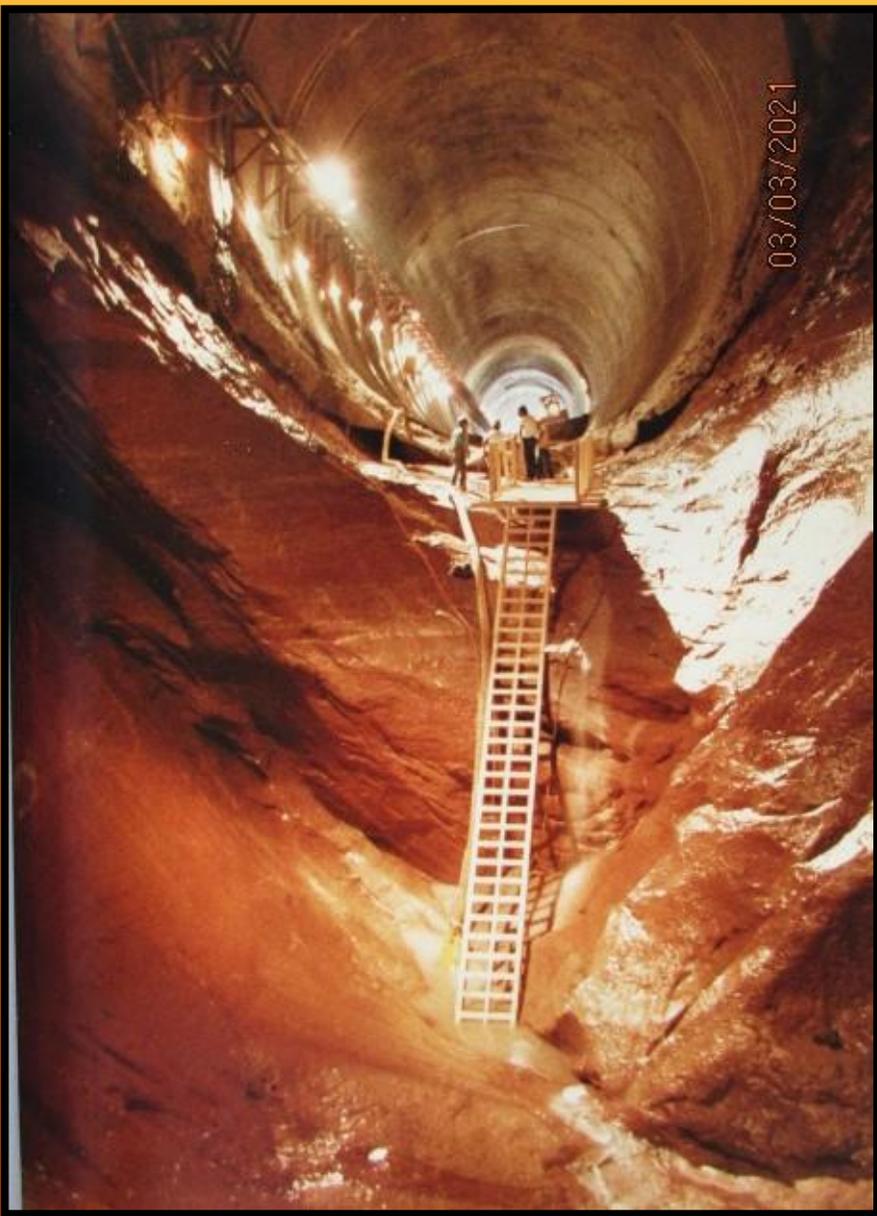
The "Hole" after dewatering,
30 to 40' deep.

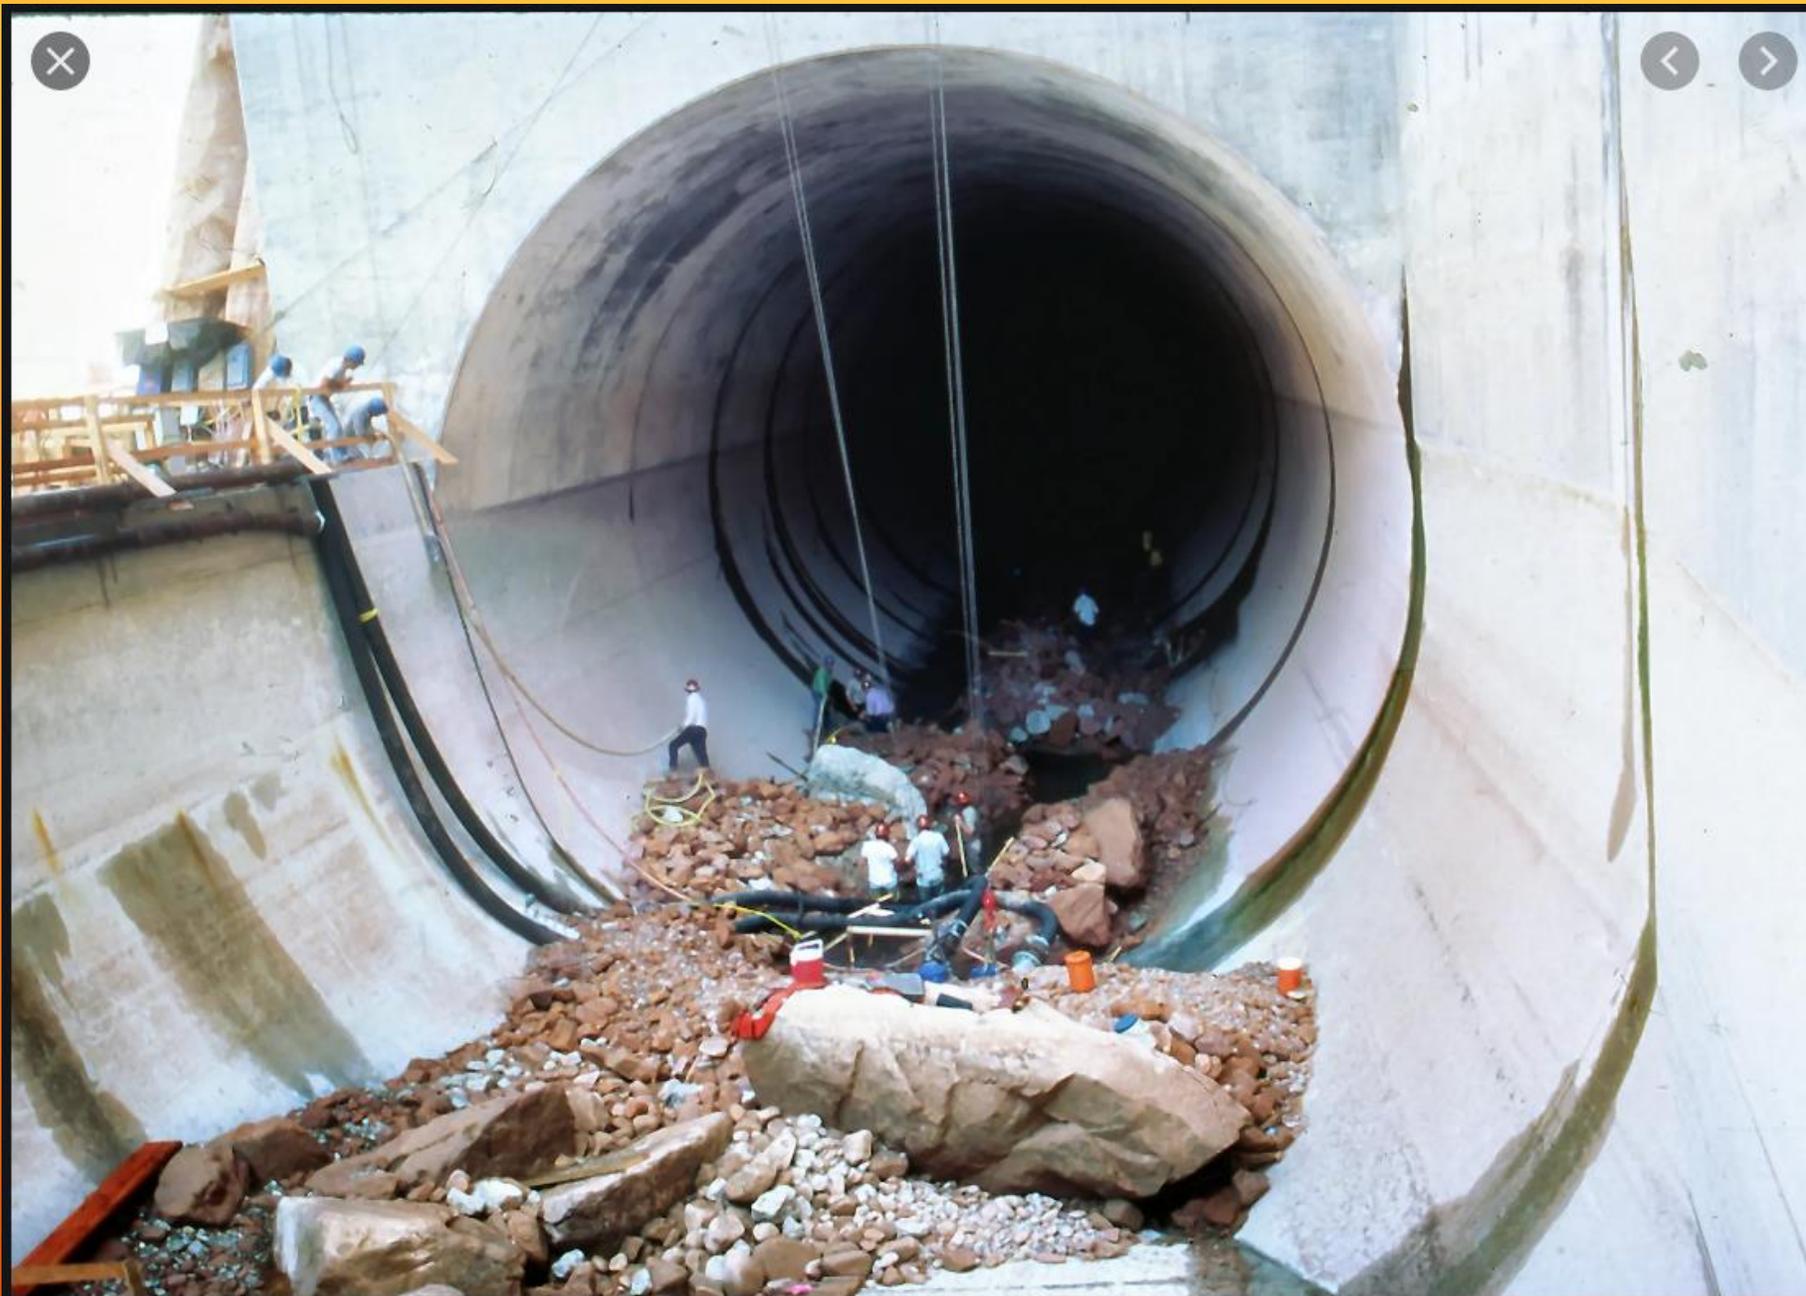
Rubble at the downstream portal.

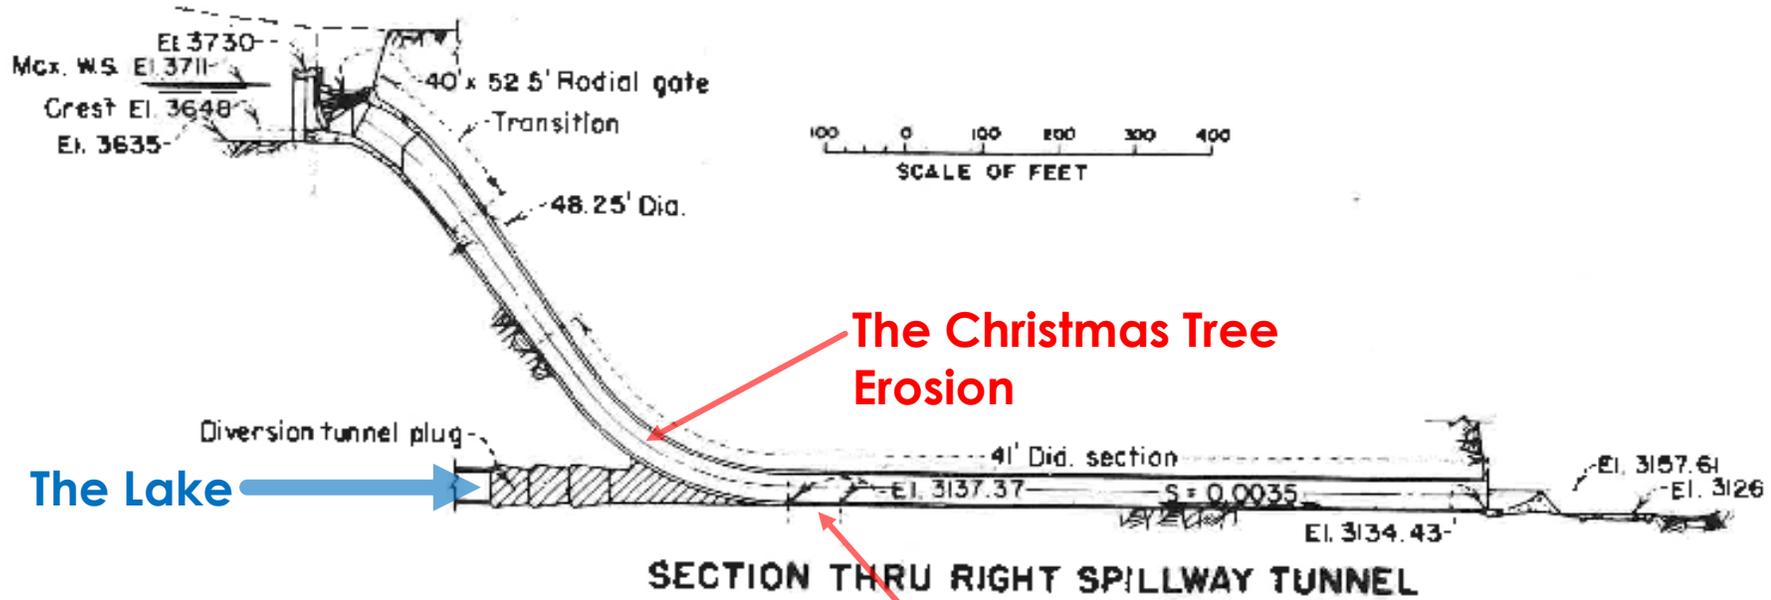
The Christmas Tree Erosion

The Hole

Potential Failure Mode = The Christmas Tree meets the Hole meets the Lake. Resulting at a minimum of a drained Lake Powell.

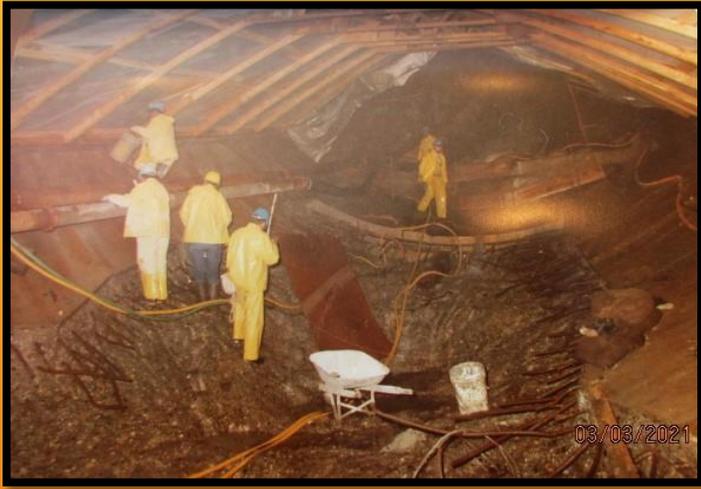
Working conditions for the men was miserable – cold – wet – and dark. Note the temporary structure built overhead to keep the seepage water away from the men and work area.

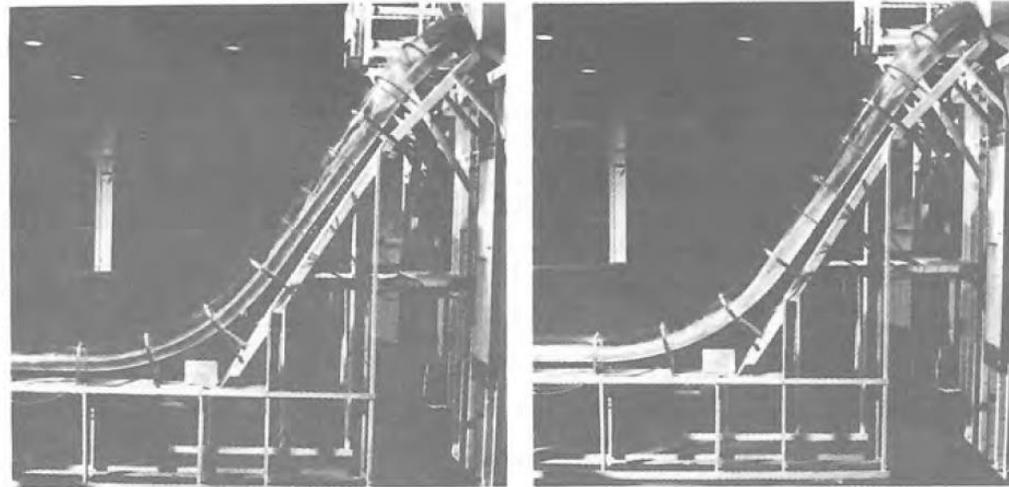
Figure 4 Glen Canyon left spillway tunnel, $Q = 100\,000\text{ ft}^3/\text{s}$ ($2830\text{ m}^3/\text{s}$).

a. Without aeration slot

b. With aeration slot

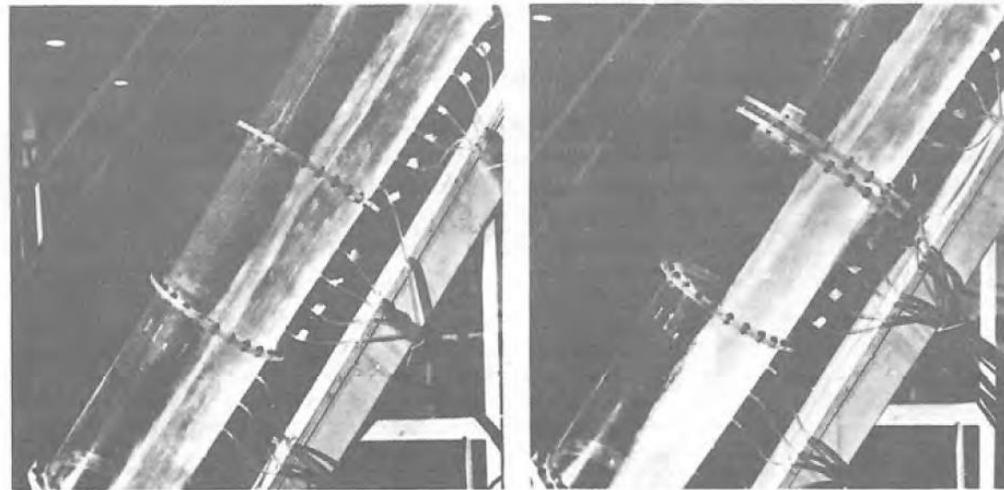
Figure 5 Sloping portion of left spillway tunnel (55° angle).
 $Q = 75\,000\text{ ft}^3/\text{s}$ ($2120\text{ m}^3/\text{s}$).

a. Without aeration slot

b. With aeration slot
