GLEN CANYON DAM SPILLWAY TUNNEL REPAIRS, 1983 - 1984

Bill McCormick, Gary Boring, Keo Civil, LLC

Contract No. 3-CC-40-01100

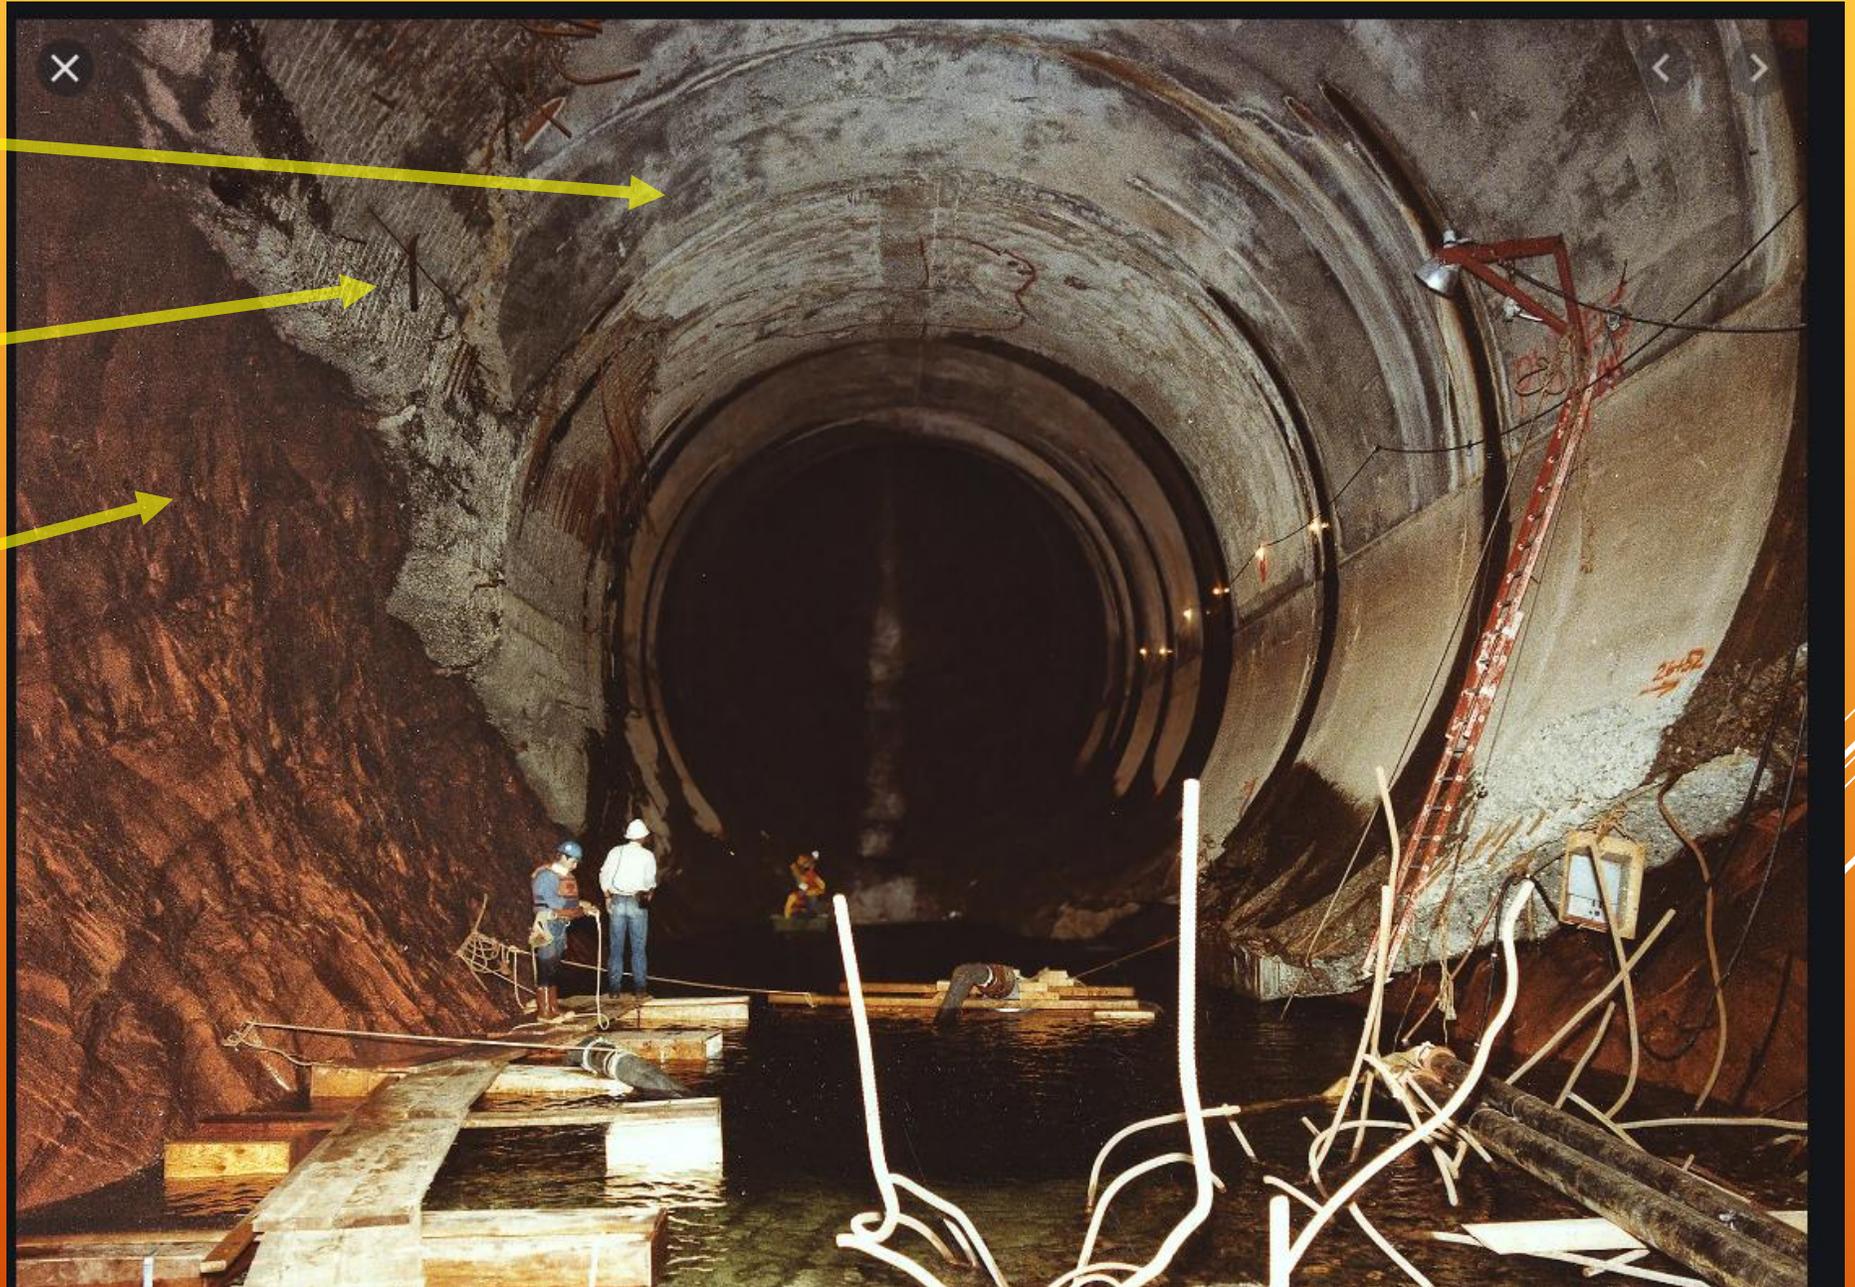
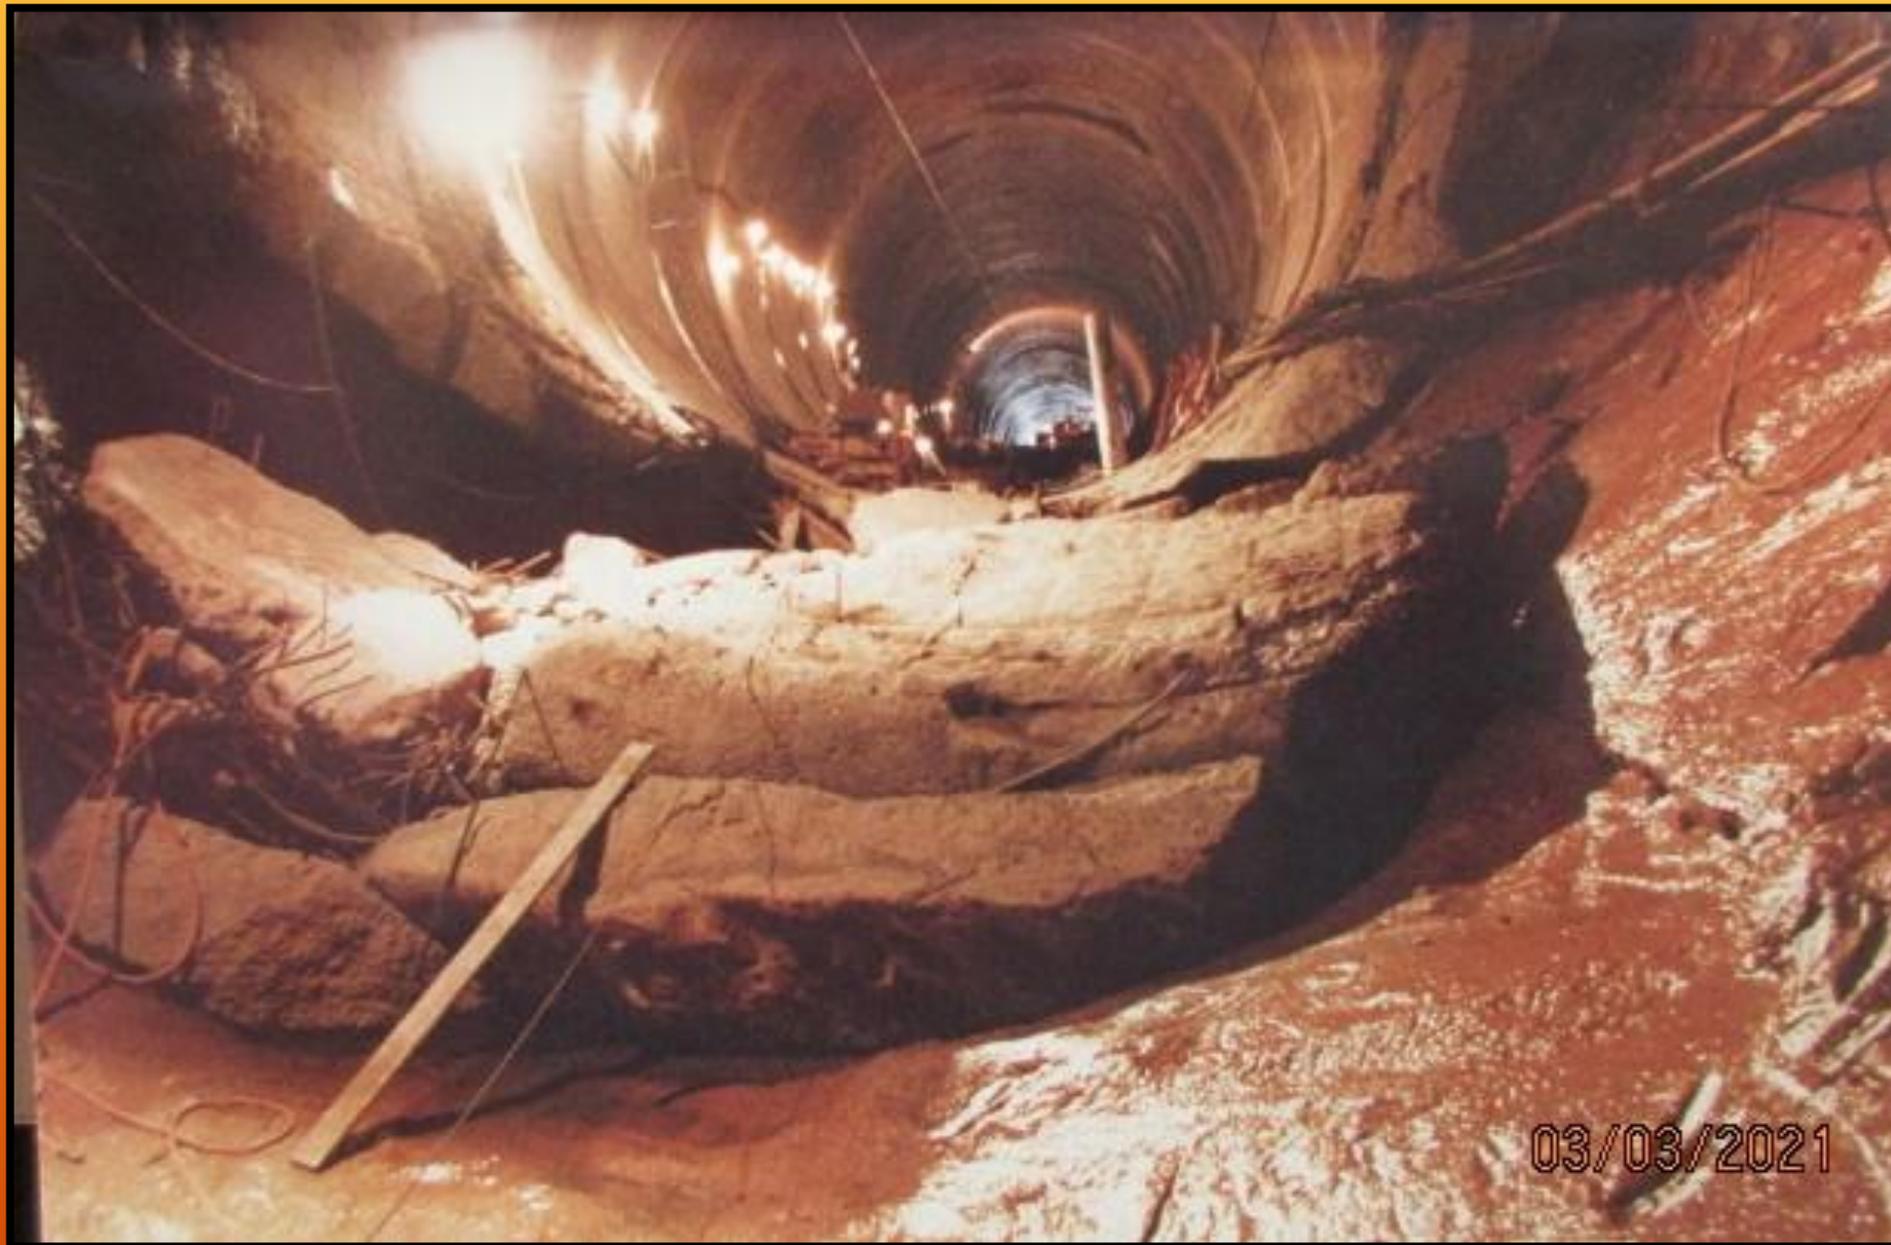
Intact Concrete Lining

Exposed Rebar

Navajo Sandstone

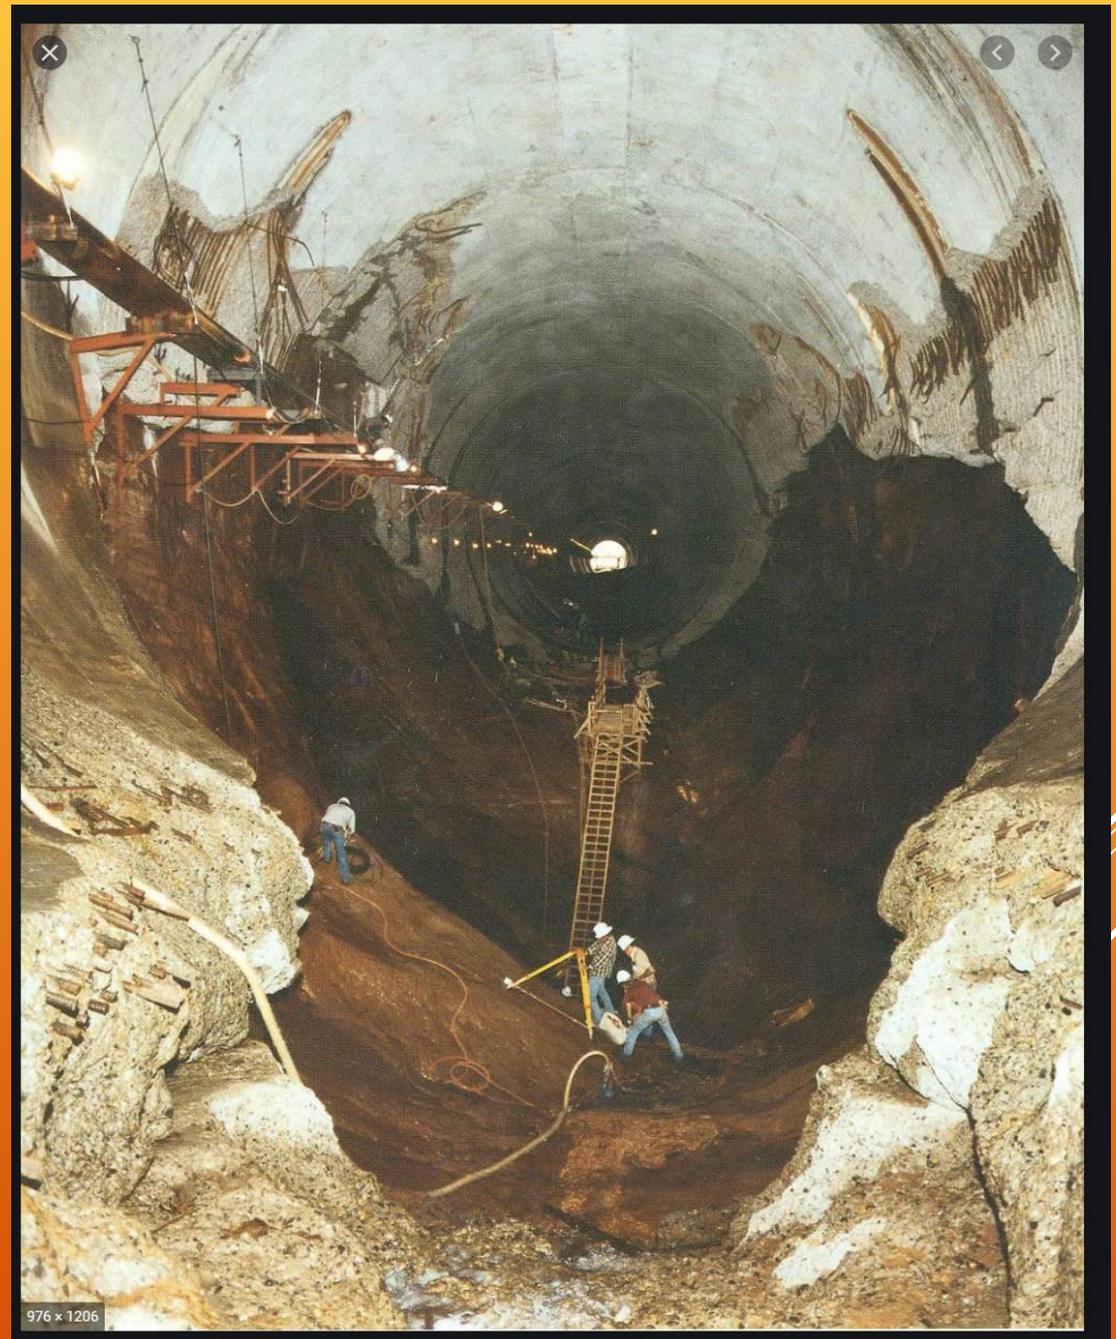
The "Hole" after dewatering,
30 to 40' deep.

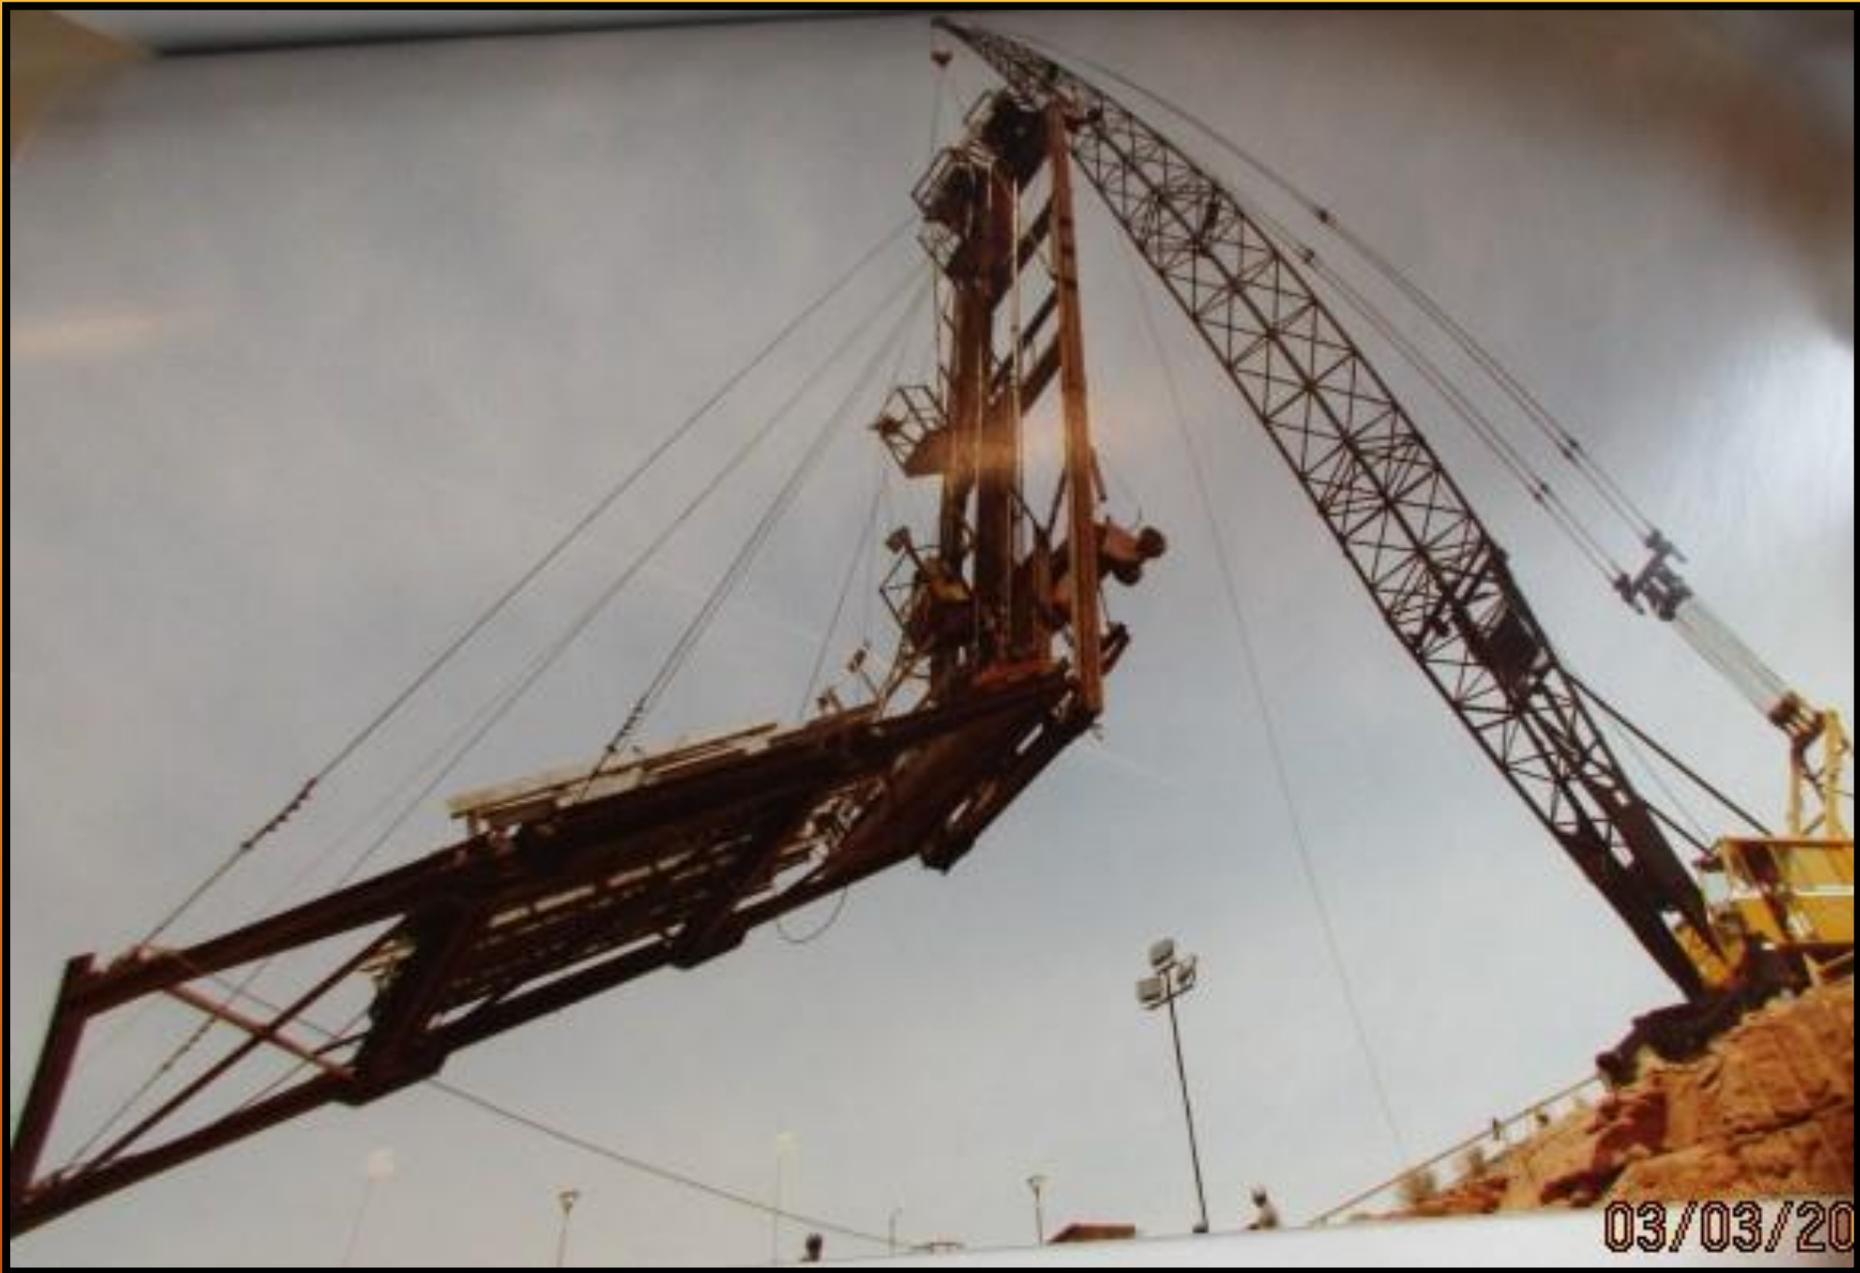
Early Aeration slot work platform – ultimately not used.

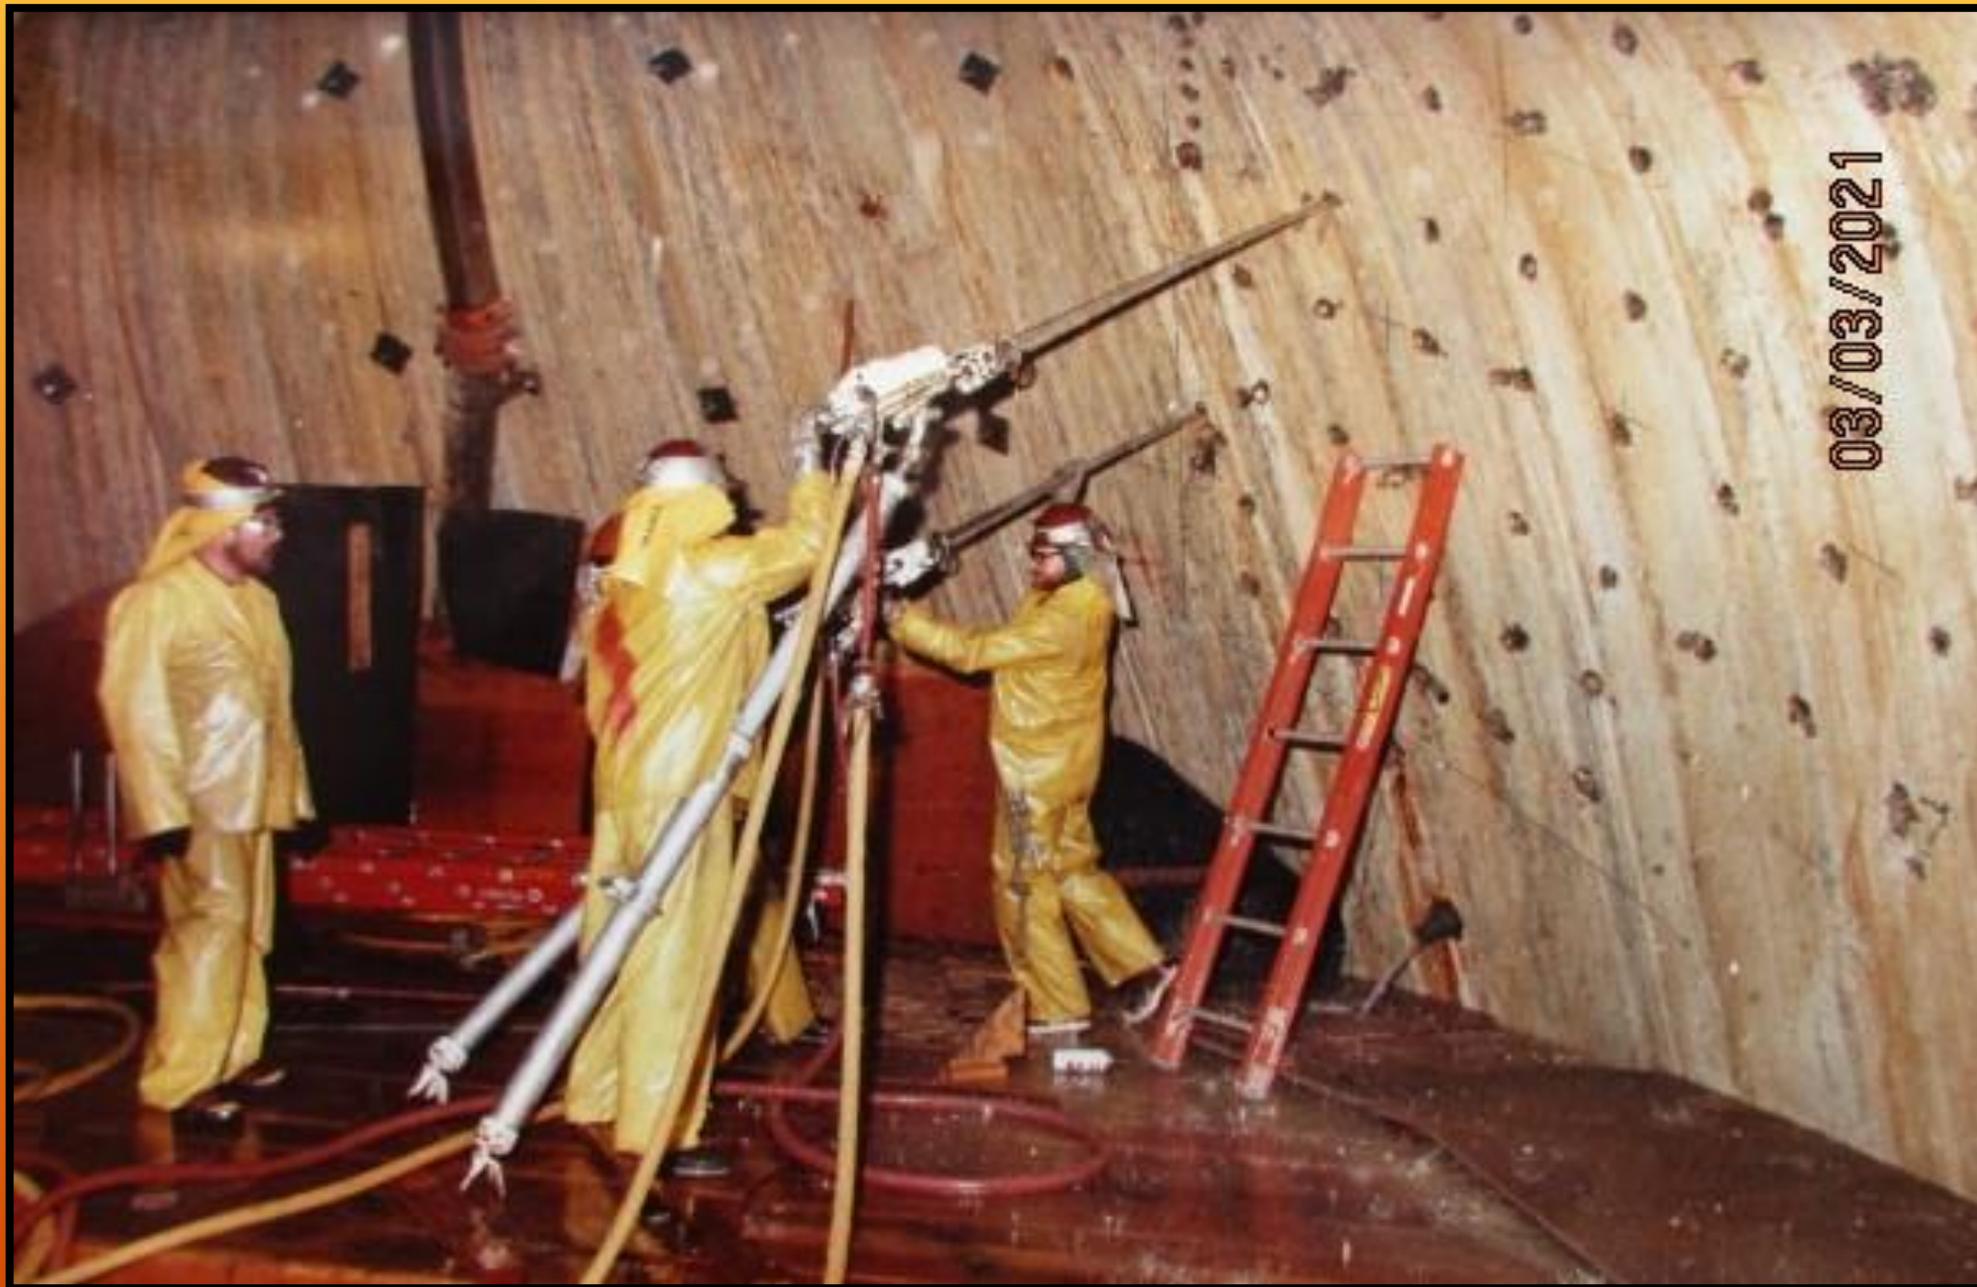
Using Jack-Leg drills for blast holes at the aeration slot.

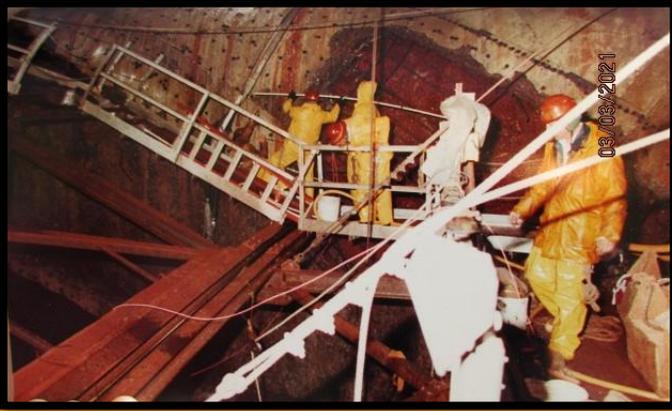
Loading the blast holes for a shot.

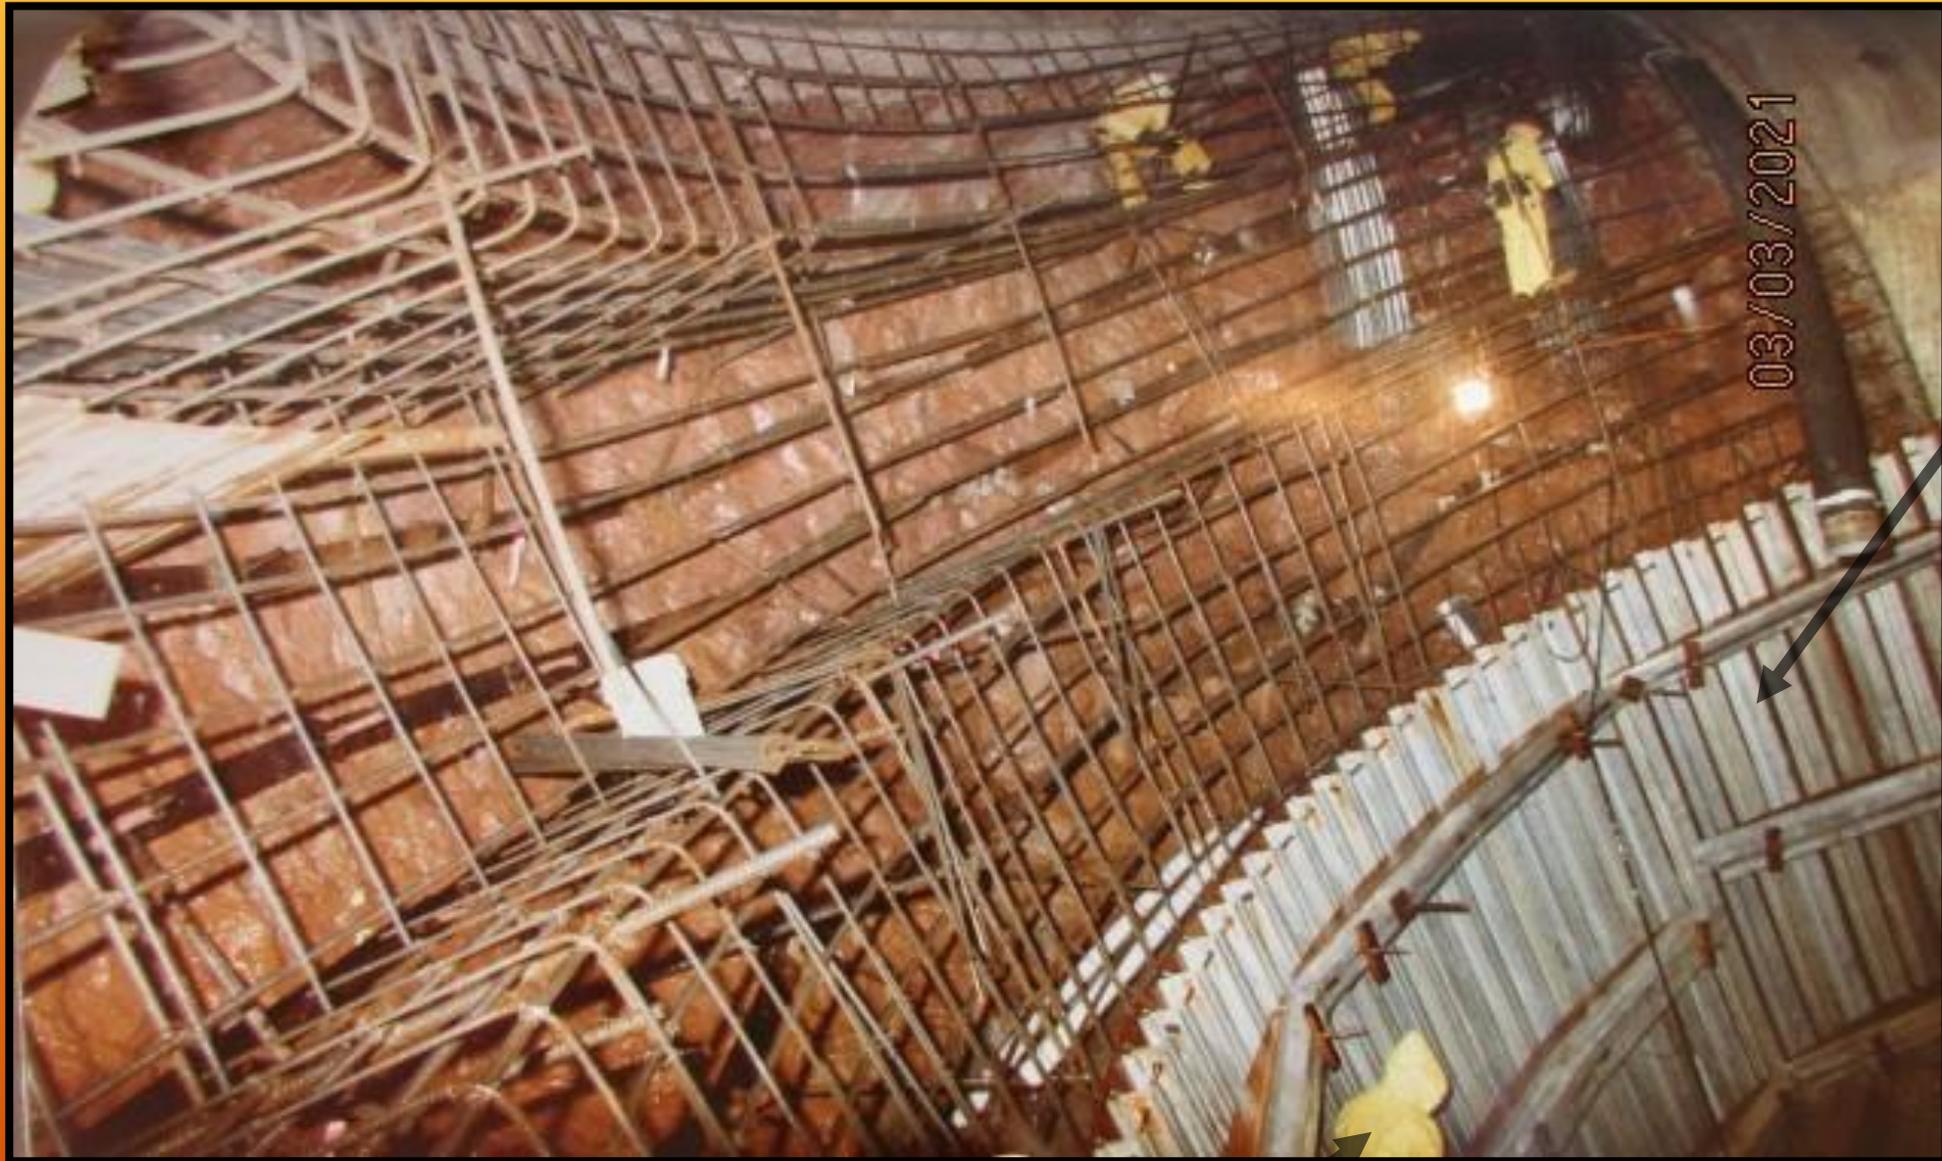
Formwork for placement #1.

Slot rebar – note how vertical the shaft is.

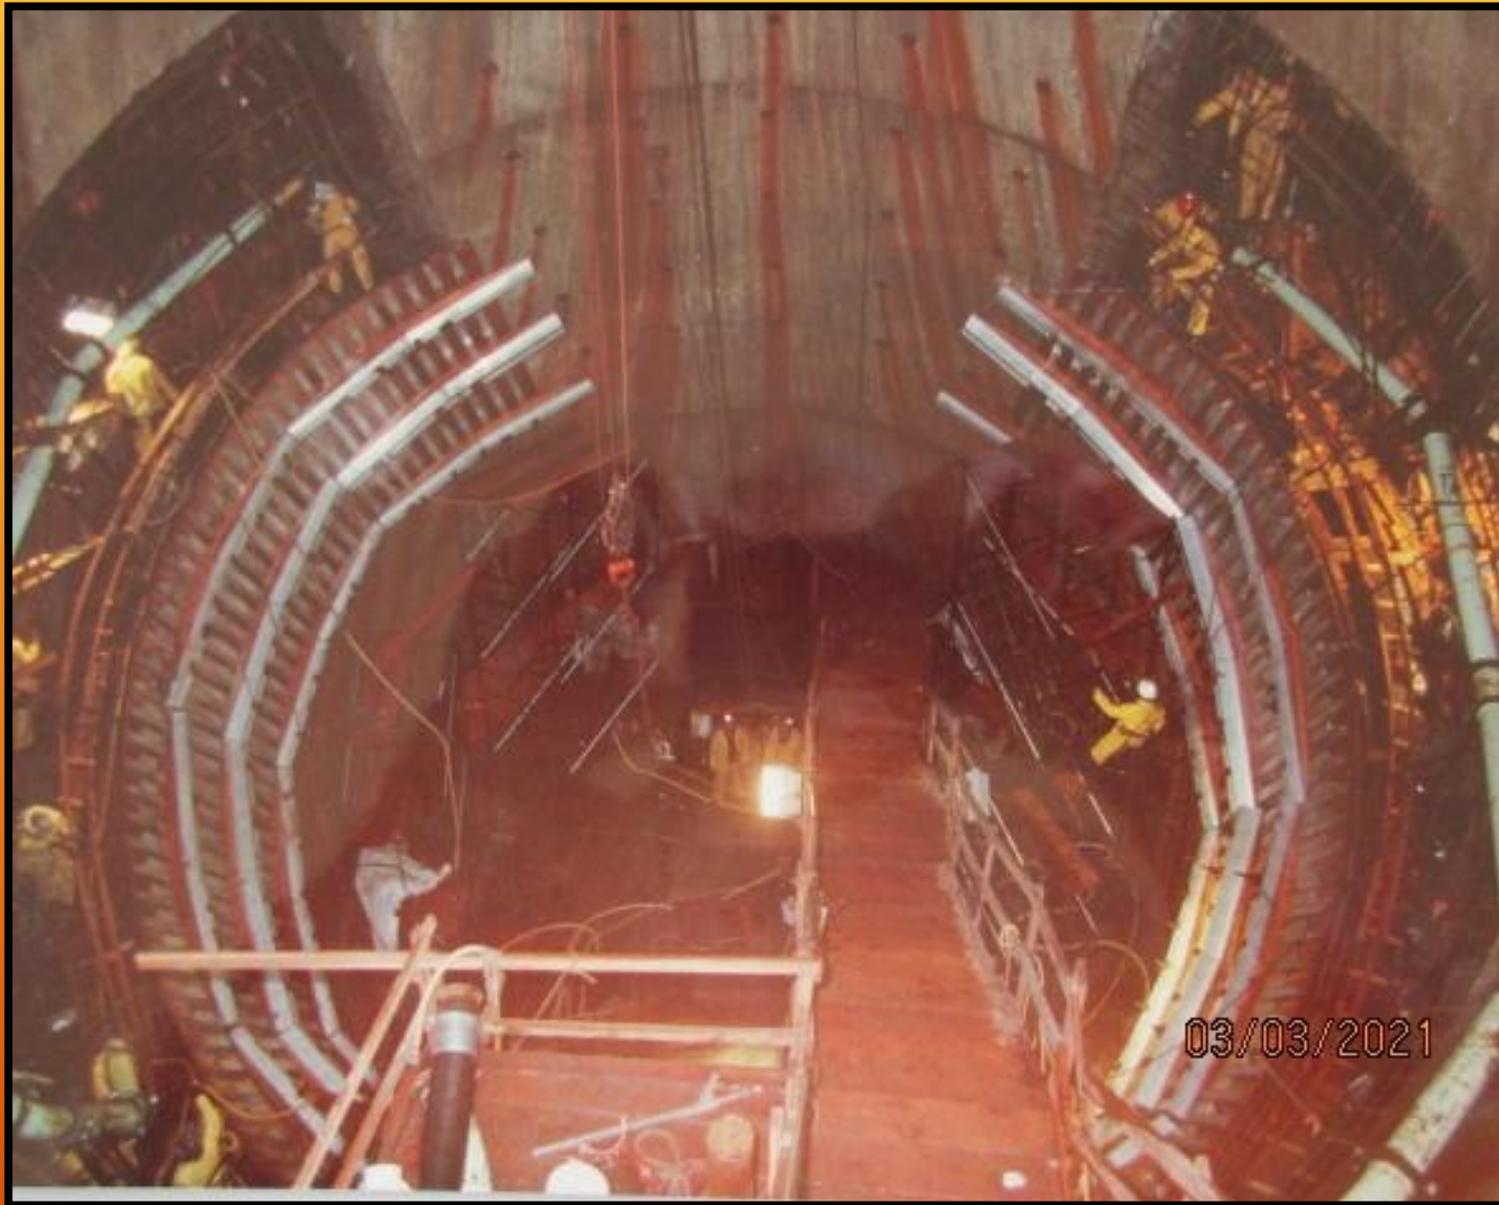
Prepping for placement #2

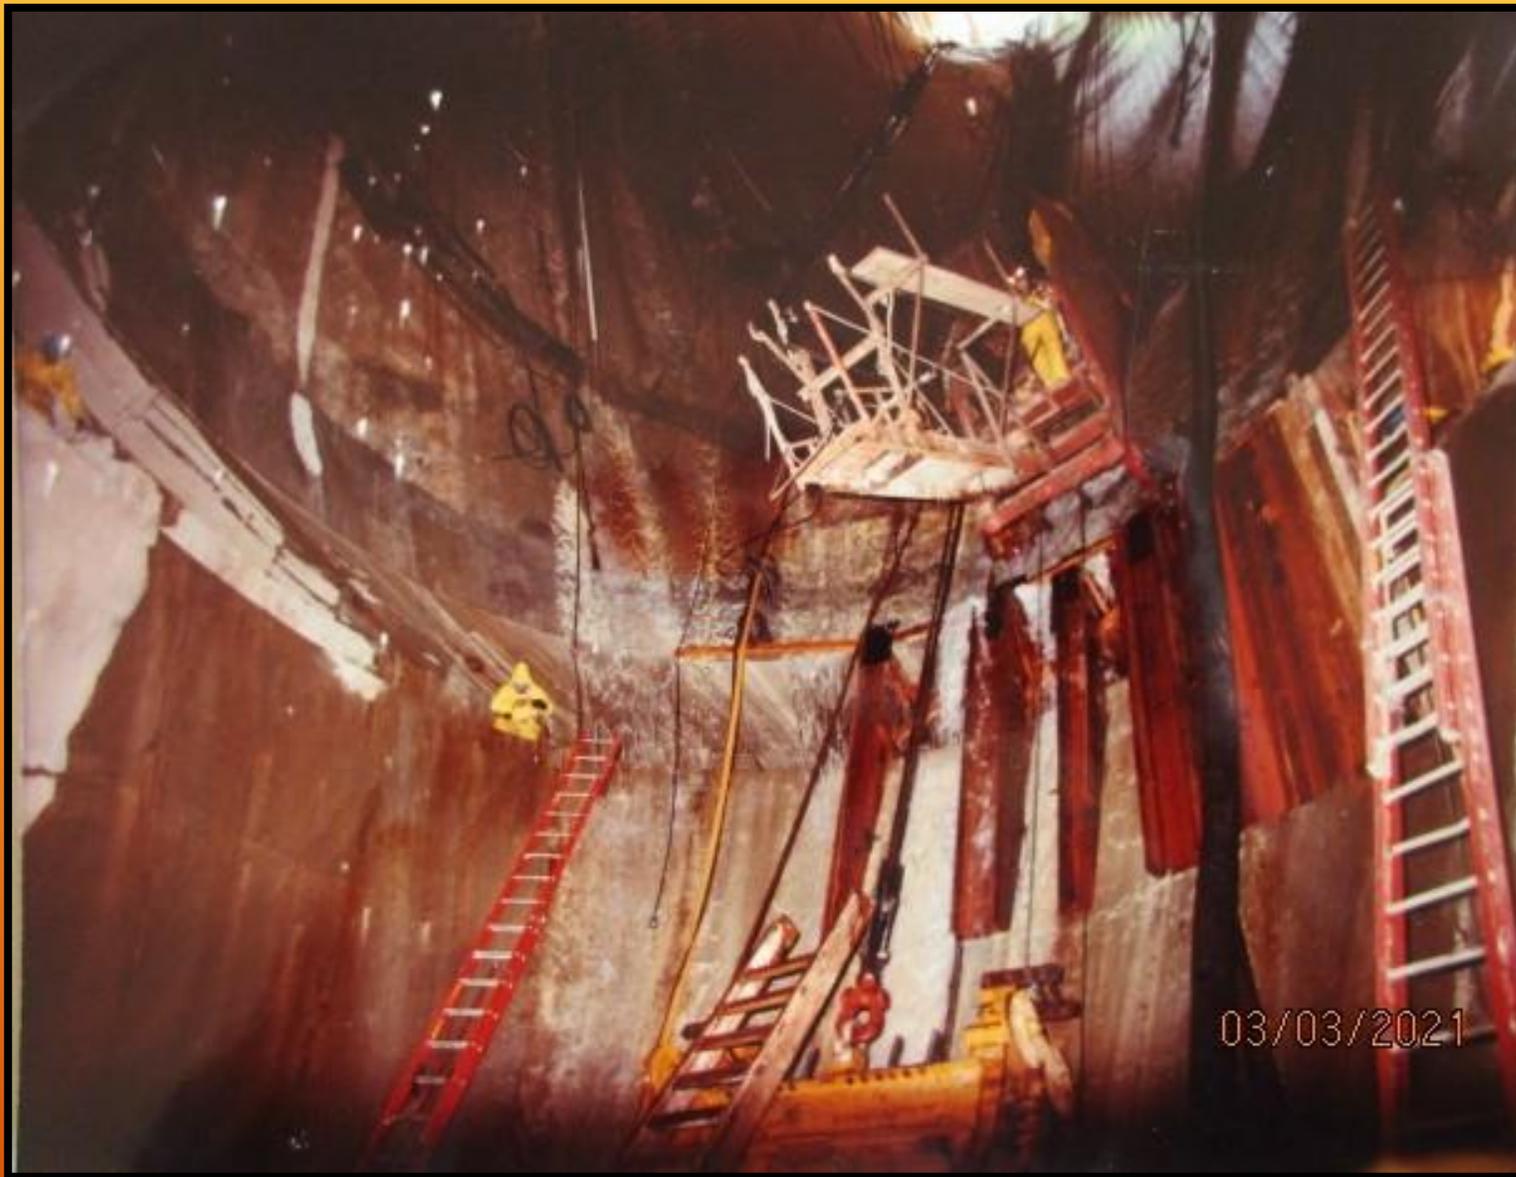
The Contractor's access skip about to cross over the slot on ramps.
